Manhole Inspection Summary

Manhole # S25C__018MH

Location Address: **338 ALLEY-CAREY-CARROLTON** Cross Street: **MULBERRY ST**

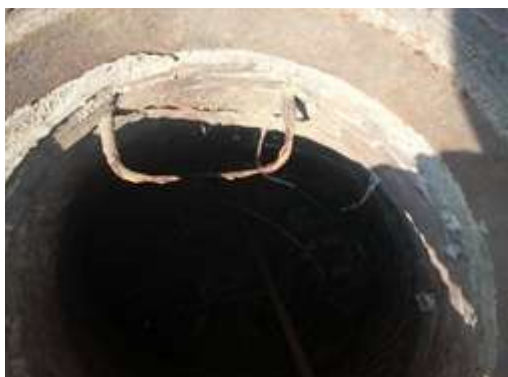
Defect 1

Steps Count: **0** Missing: **4** ☒ **Corroded**

MISSING STEPS

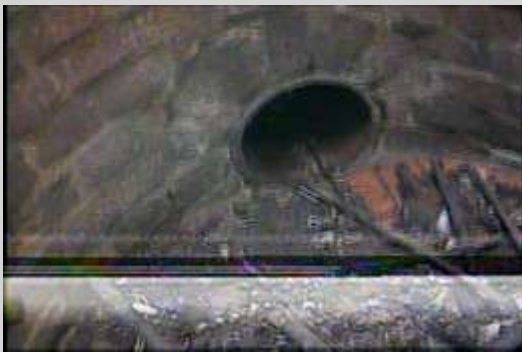
12 O'Clock Outflow

8 in. Circular Gravity Sewer
Pipe Out @ 12 O'Clock

Deposits: ☐ None ☐ Mud ☐ Sludge ☒ **Debris** ☐ Grease

Silt Depth: **1** (in.) Deposits Extent: **Light**

Infiltration: **None** Pipe Seal Cond: **Sound**
